Non-Routine Application and Bridge Load Rating Using BrR

C.Y. Yong, P.E., S.E., ENV SP

Dongzhan (Jenny) Raines, P.E.

October 3, 2022

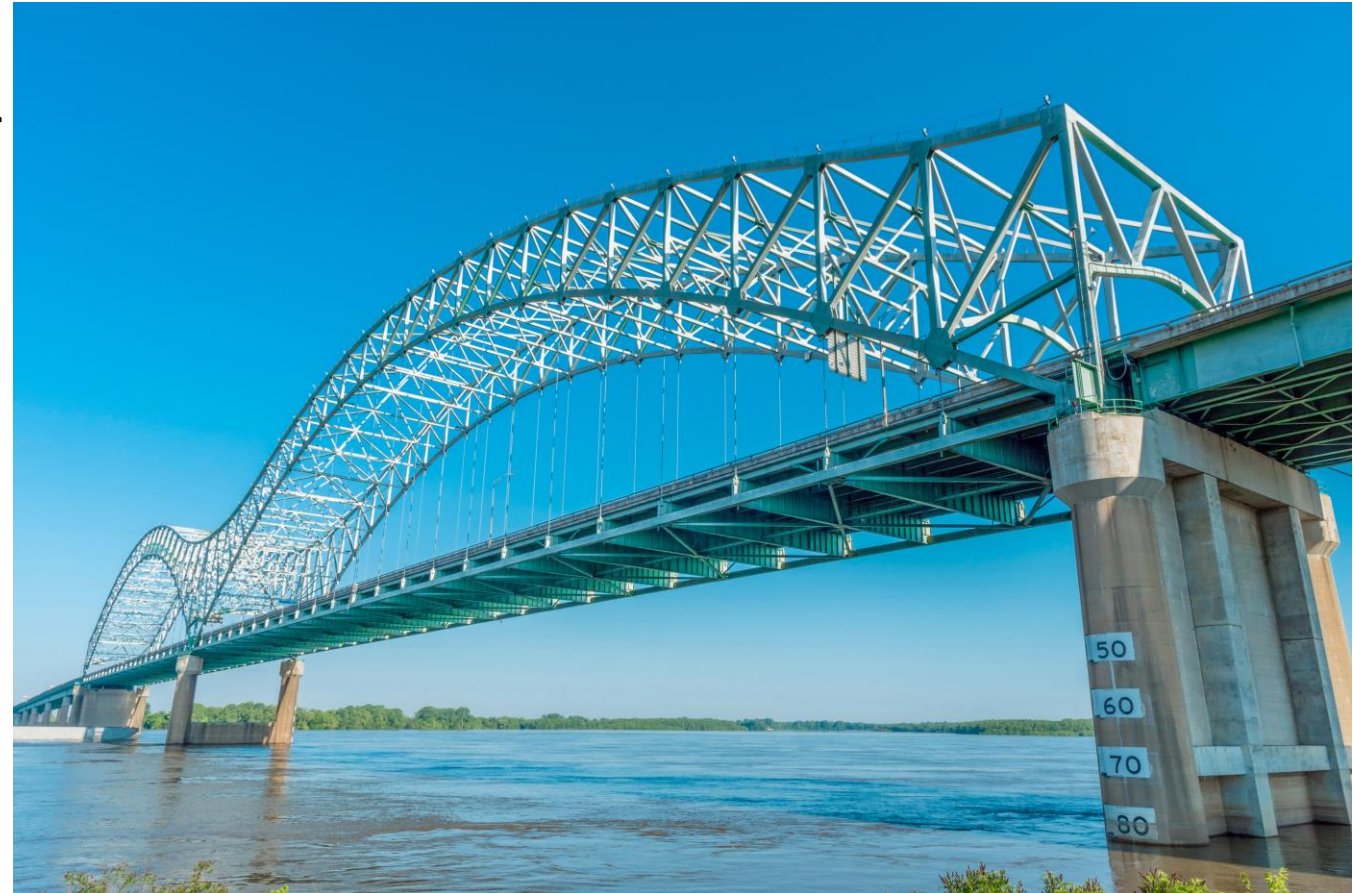
Case Study 1 – I-40 Hernando de Soto

- Hernando de Soto Bridge
 - Carrying I-40 over Mississippi River
- Constructed 1967-1973
- Two 900' Span Continuous Tied Arch Bridge
- Emergency Repair – Summer 2021
- Post repair load rating

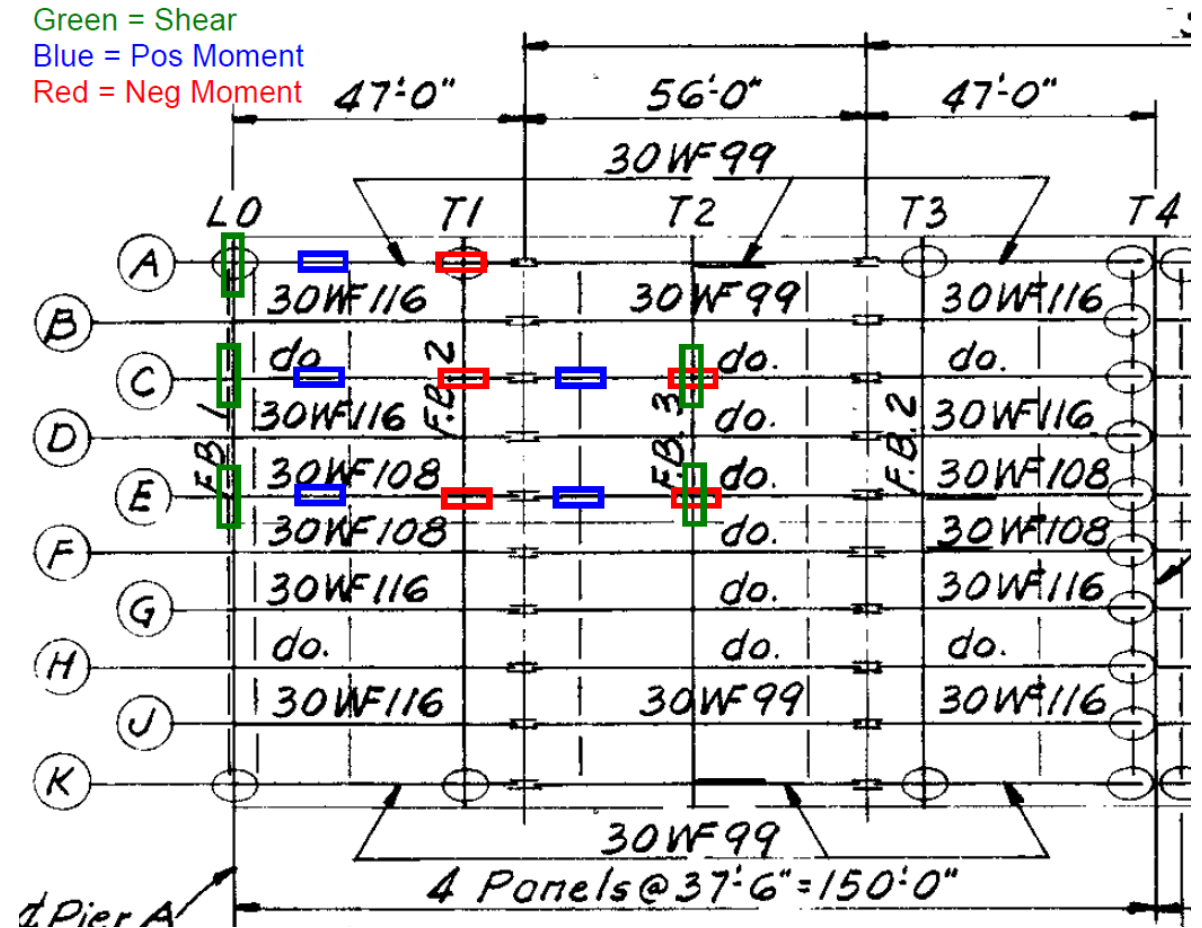
Results

- Controlling point of interests of each unique stringer line
- Validated with hand calculation
- Populate capacity and demand into a load rating tool

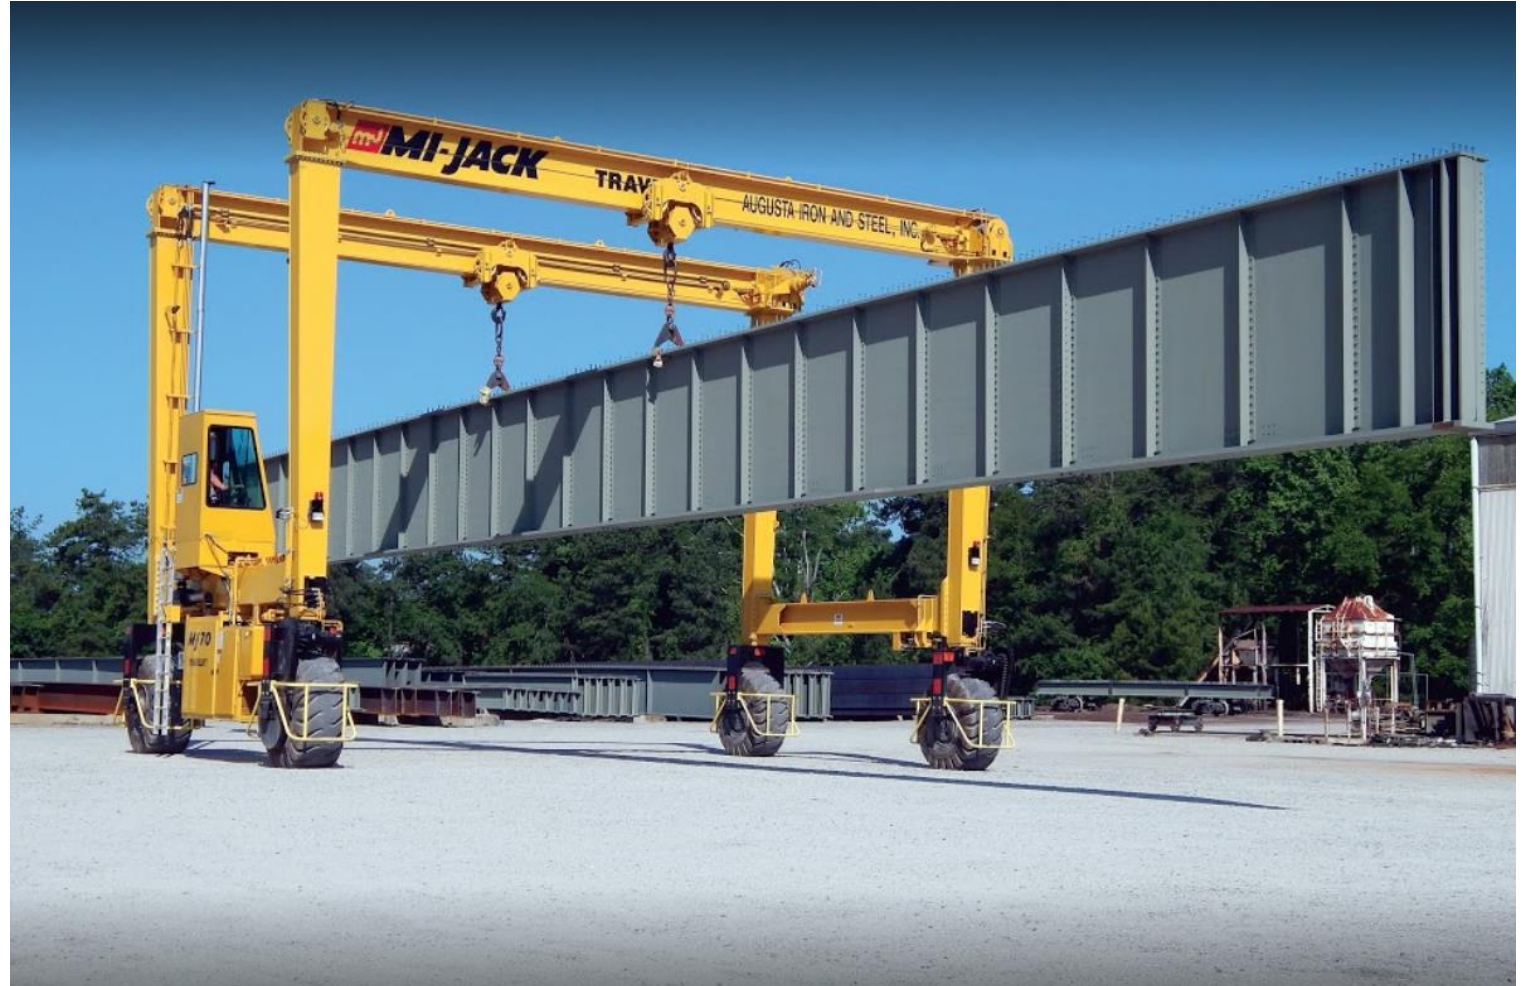
Site Access: Railroad Must Stay Open

- 2 – 40 tons Mi-Jack Cranes
- 1 wheel line on each bridge
- 50 kips/wheel

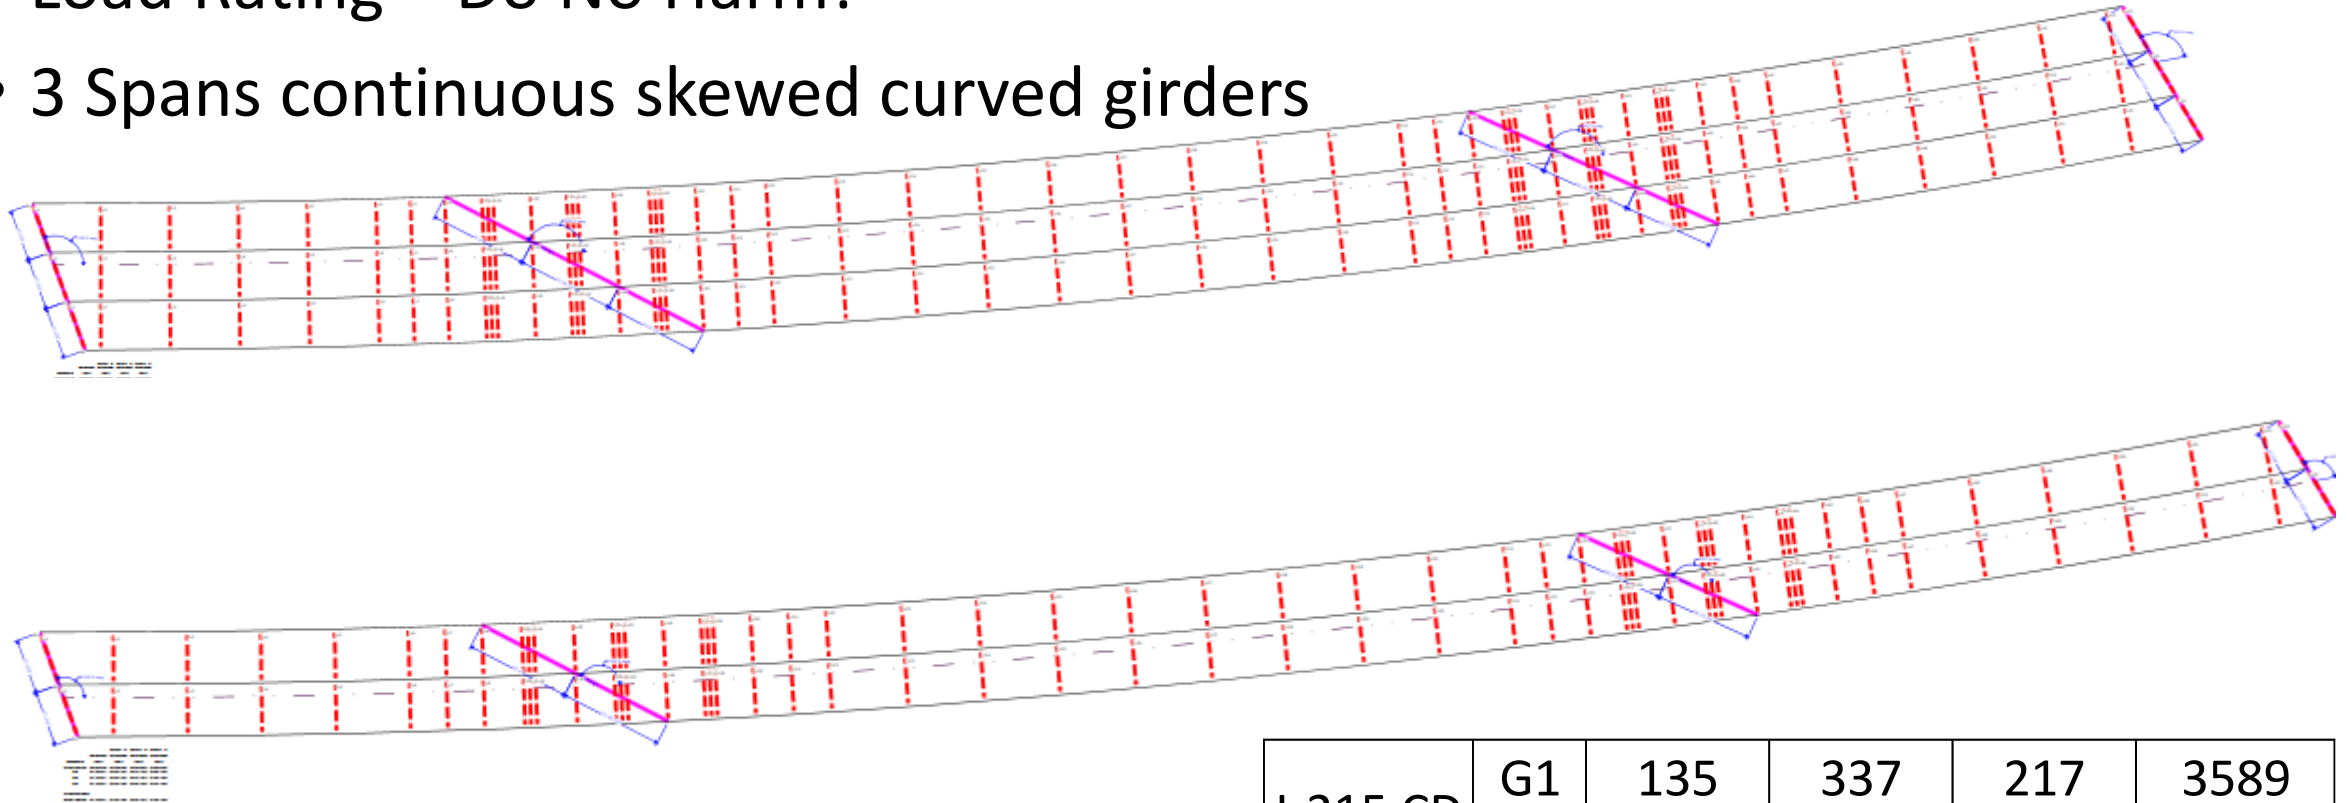
BrR Model

- Load Rating – Do No Harm!
- 3 Spans continuous skewed curved girders

I-215 CD	G1	135	337	217	3589
	G4	203	335	161	3637

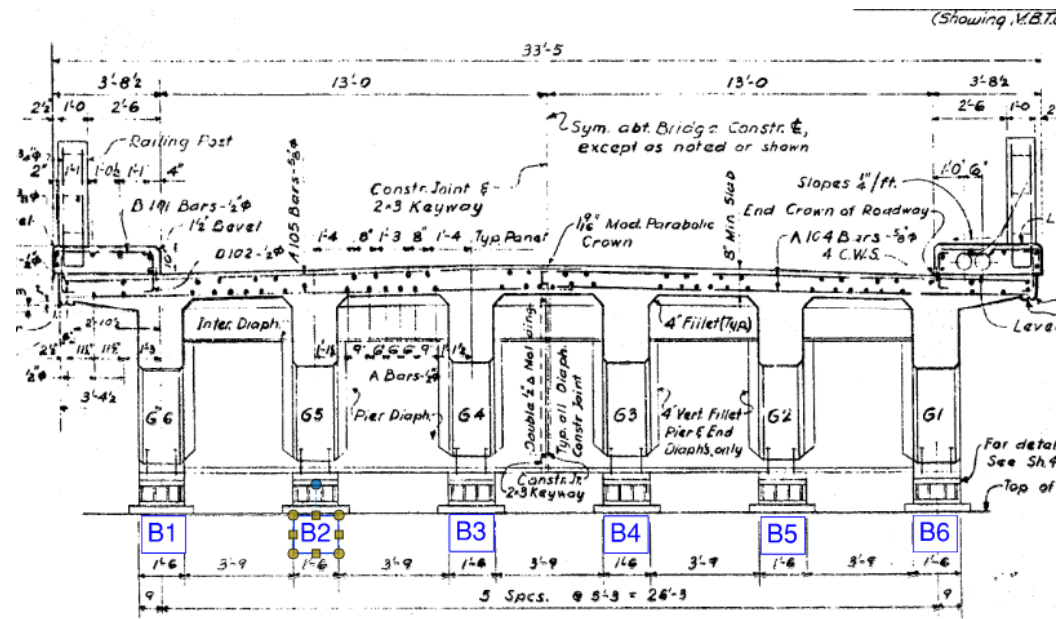
- Reinforced concrete tee beam system

TYPICAL CROSS SECTION
Tee Girder Reinforcement not shown

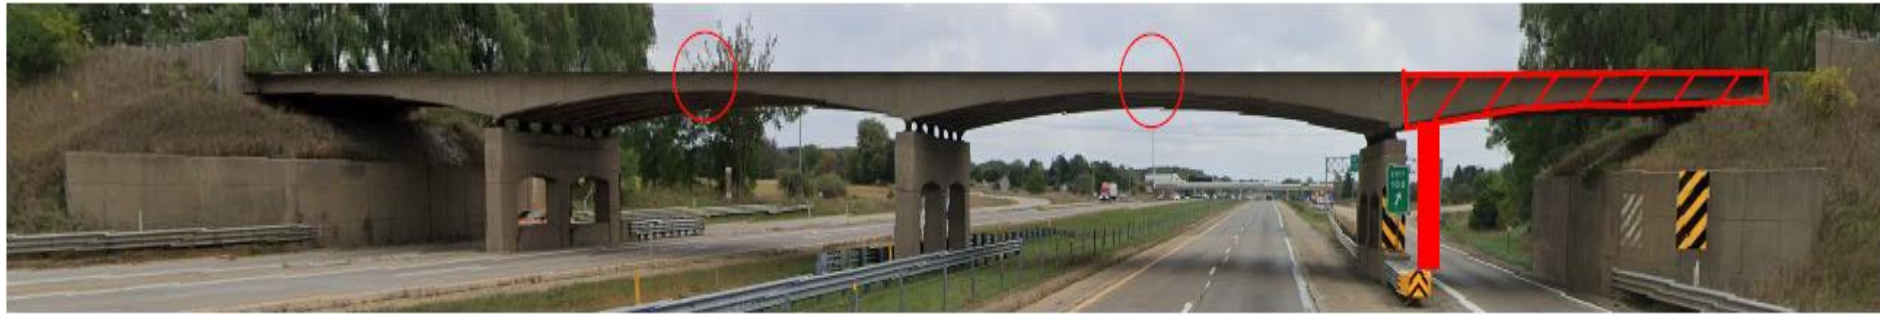
- Removing Span 4

- Evaluate structural strength and stability
- Comparison of beam moment diagrams (dead load only)
- Removal of span could cause other spans to fail

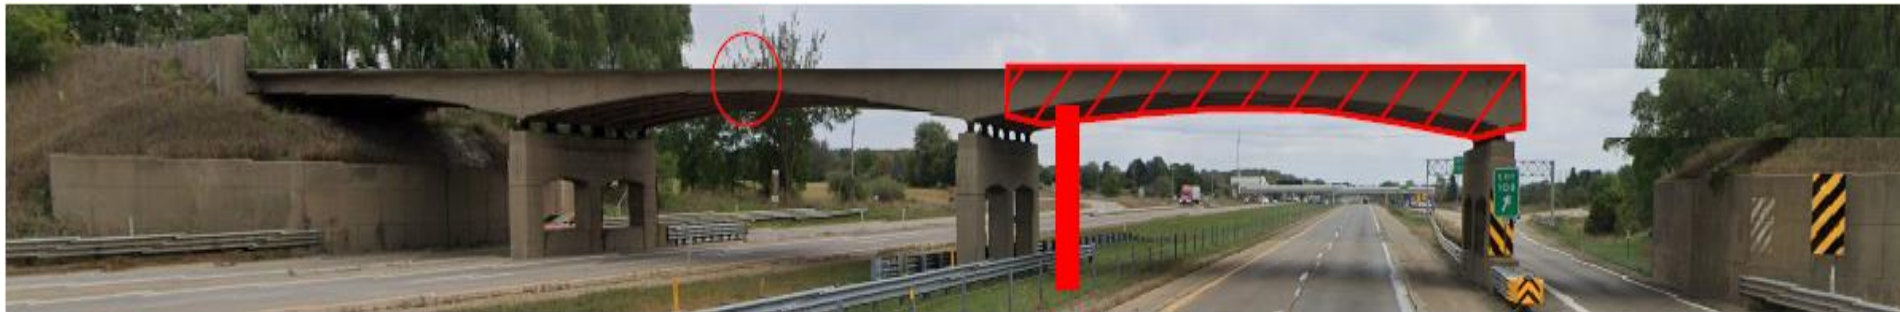
- Removing Span 4 & 3

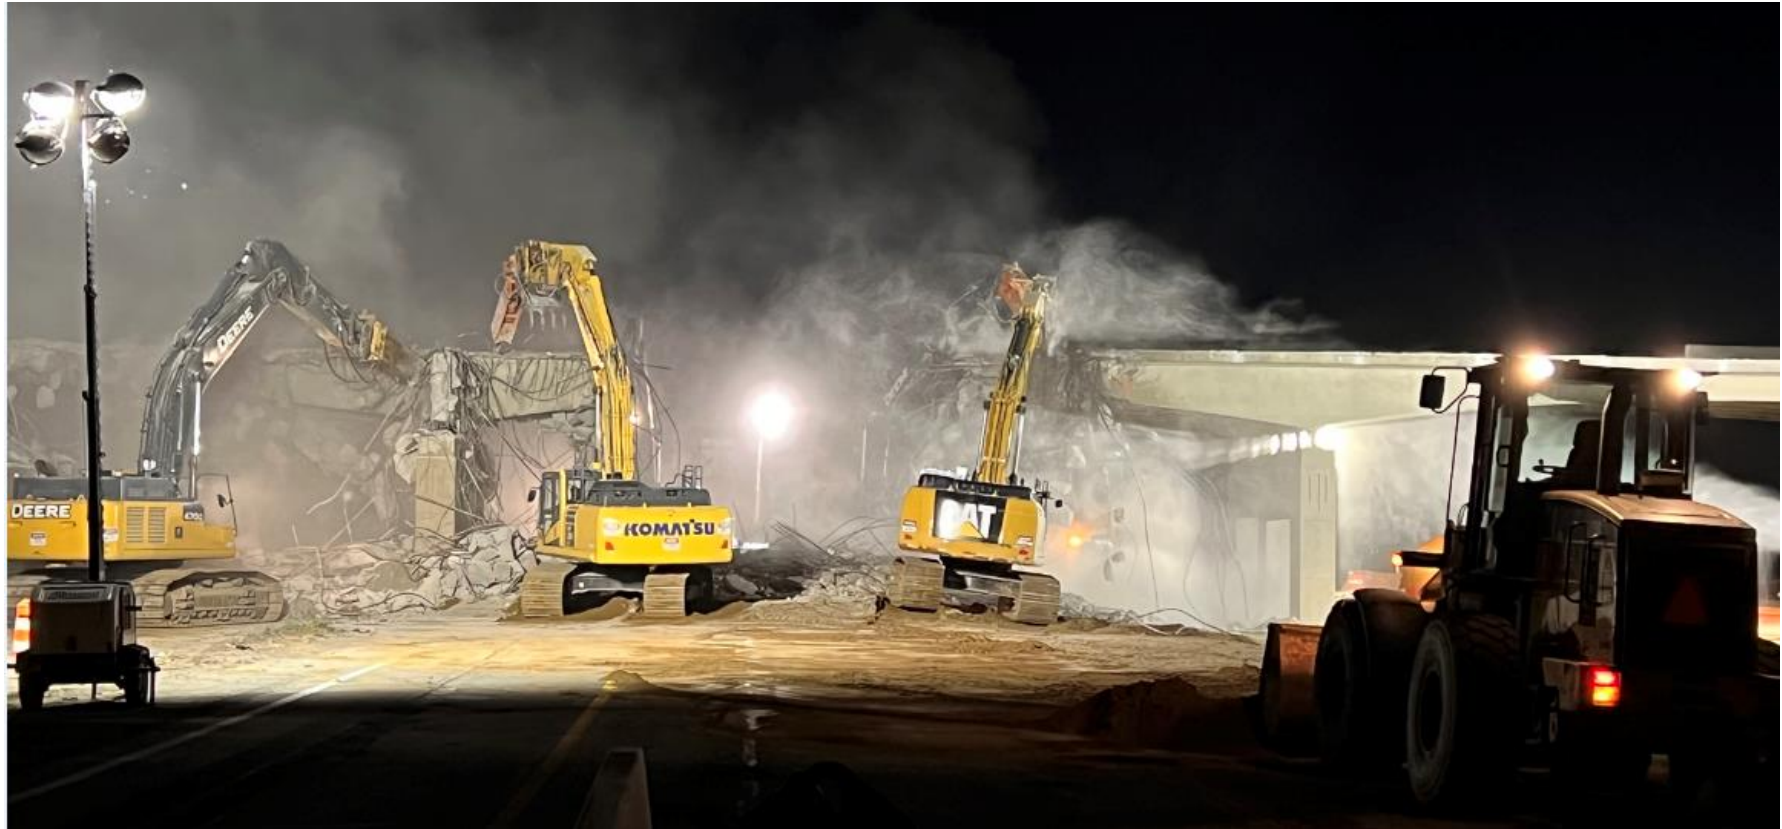
Demolition Method

- Hydraulic Breakers: use boom-mounted excavators to break apart bridge components

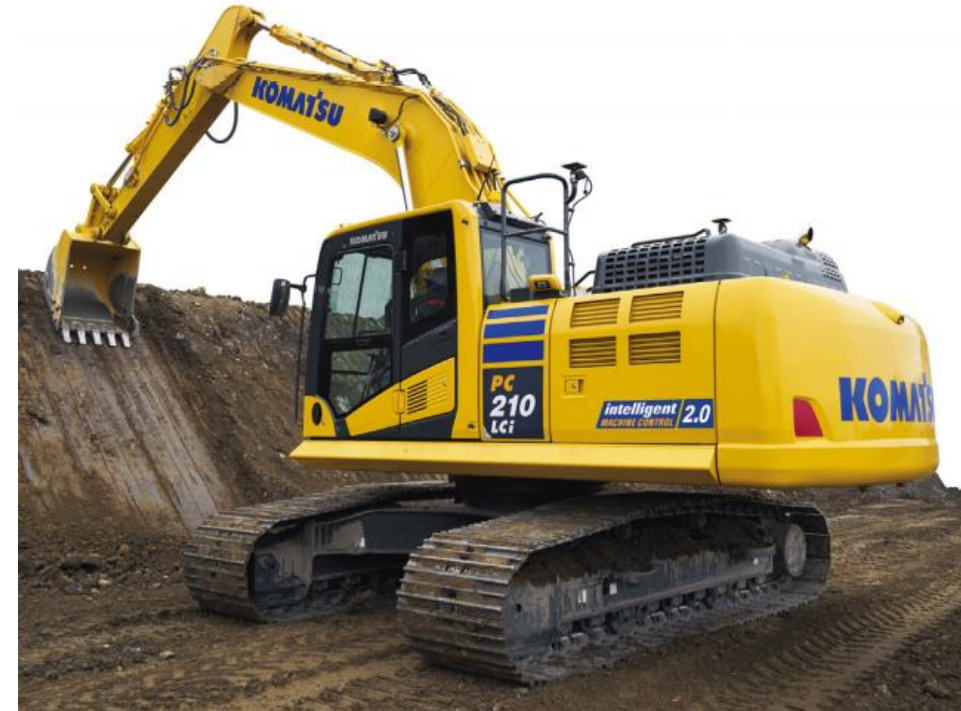
Load and Load Factors

- No significant construction dead loads are anticipated on the structure
- LL using KOMATSU 210 Hydraulic Excavators
- 70%/30% wheel distribution is used to account for lifting/working over the front or over the side for unequal loading between tracks
- Dynamic load allowance of the excavators uses 33% of the total axle weight. The estimated dynamic effect is less than 20% of the axle weight.
