The US 50-Blue Mesa Bridge Emergency Repair

Jonathan Beckstrom, P.E., S.E.

Michael Baker International

2025 Rating and Design User Group Meeting
Boise, ID | August 12-13, 2025

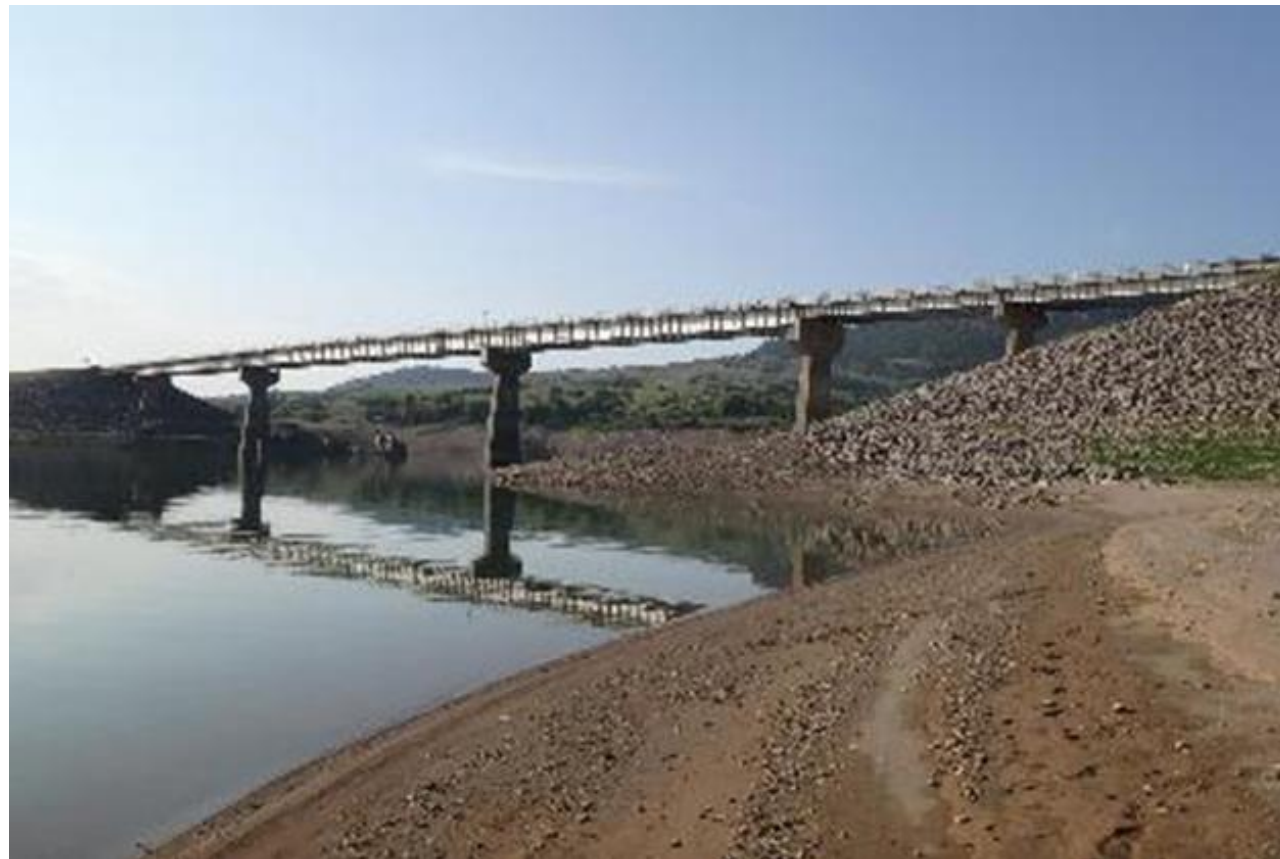
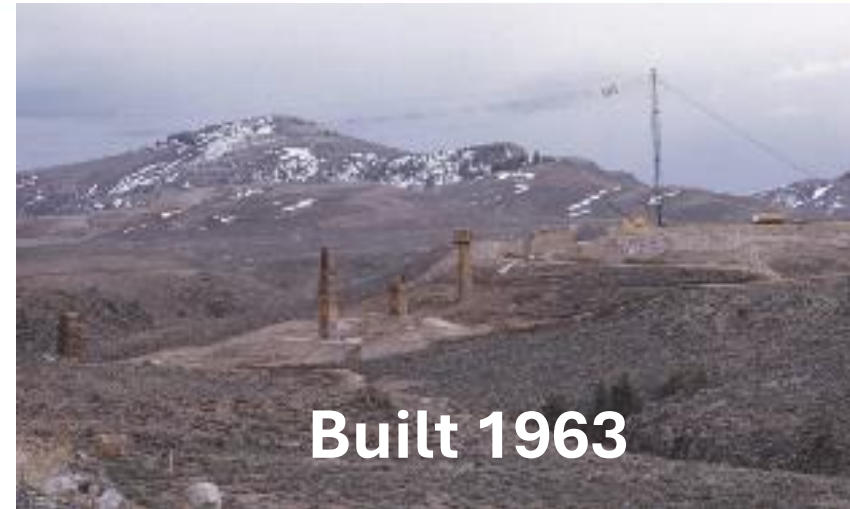
K-07-A

- US 50 over the Lake Fork at mile marker 132.69
- Six Span, Continuous Composite Welded Girder bridge. 993ft, 300ft max span
- Spans three, four, and five are Non-redundant Steel Tension Members (NSTM)
- Two total lanes, one lane each direction
- Built 1963, FAIR Condition

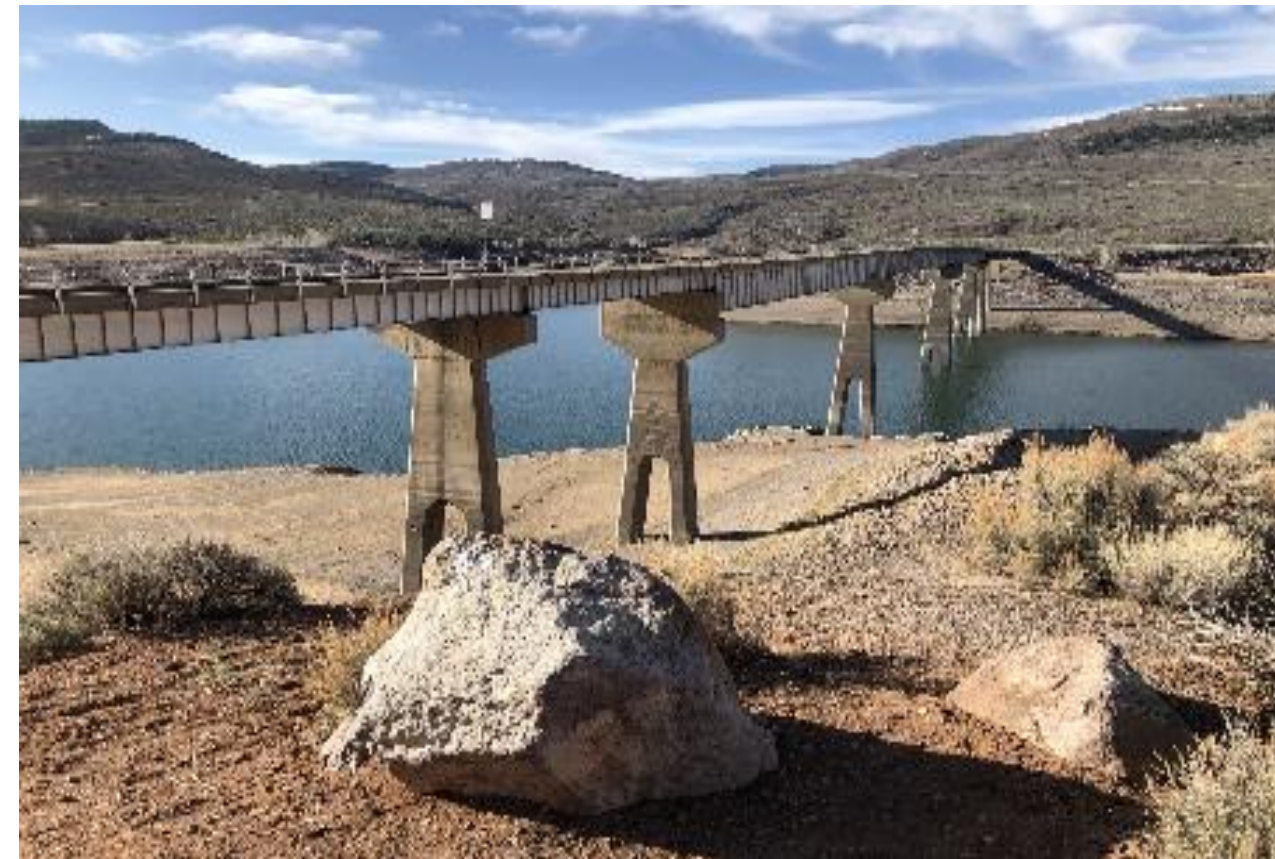
K-07-B

- US 50 over the Blue Mesa Reservoir at mile marker 136.16
- Ten Span, Continuous Composite Welded Girder bridge. 1,532ft, max span 360ft
- Spans five, six, and seven are Non-redundant Steel Tension Members (NSTM)
- Two total lanes, one lane each direction
- Built 1963, FAIR Condition

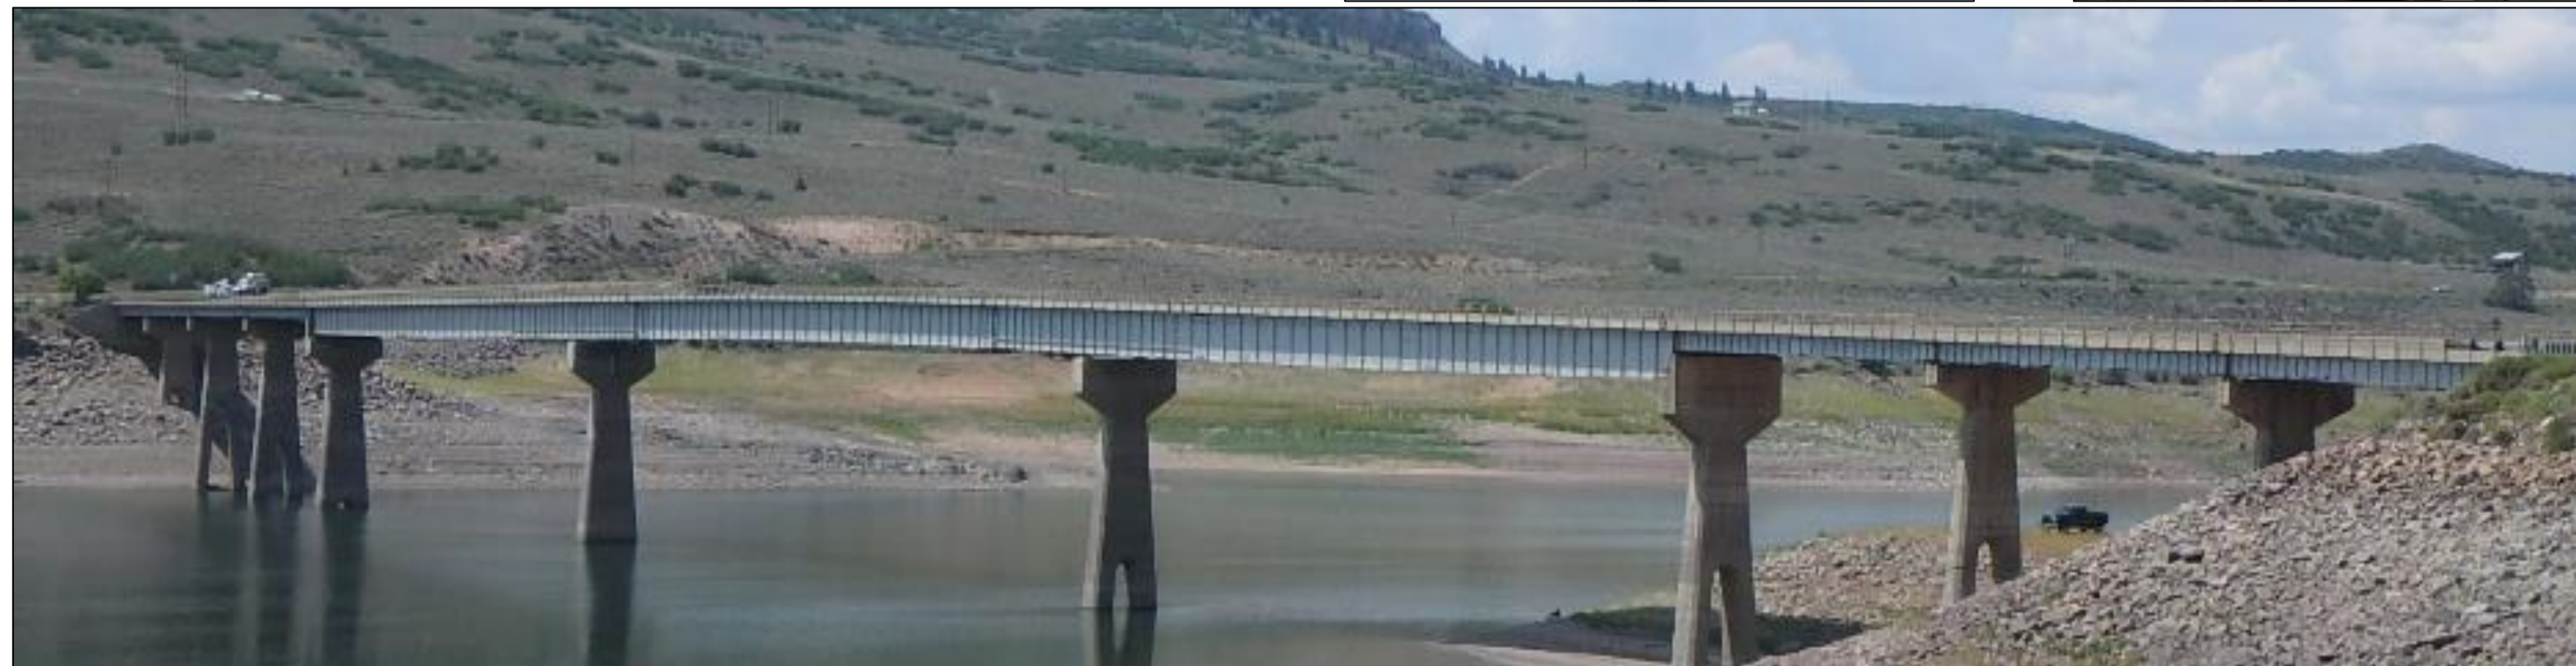
What Is T1 Steel?

- High strength steel developed in the 1950's and used 1960s - 1980s
- ASTM A514 or A517 designation
- $F_y = 100 \text{ ksi}$ / $F_u = 110 \text{ ksi}$
- T-1 is US Steel Marketing name
- Weldability issues ended its use in bridges

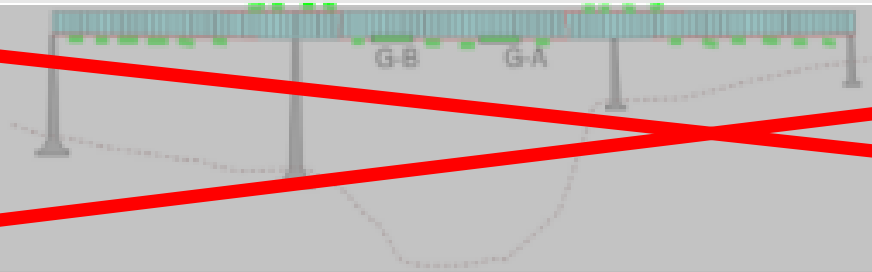
Options	Sketches	Risks or unknowns	Schedule ^{1,2}	Relative cost ³
Local Plating

<ul style="list-style-type: none">• Increased complexity if additional defects are later found. Relative costs increase with the number of defects found.	1 – 3 Months	\$ - \$\$\$
Global Plating

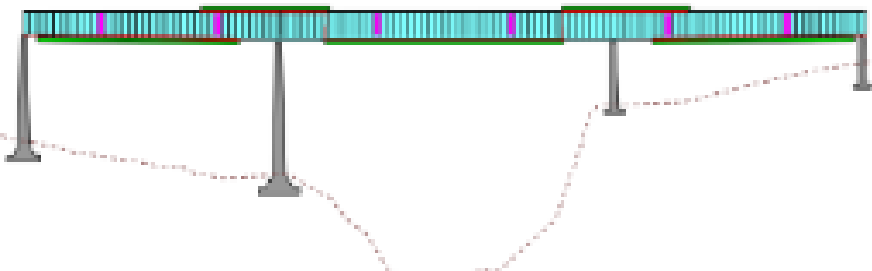
<ul style="list-style-type: none">• Material availability• Sequence of construction• Negative effects of additional weight• Schedule risk due to design complexity	4-7 Months	\$\$\$
Superstructure Replacement

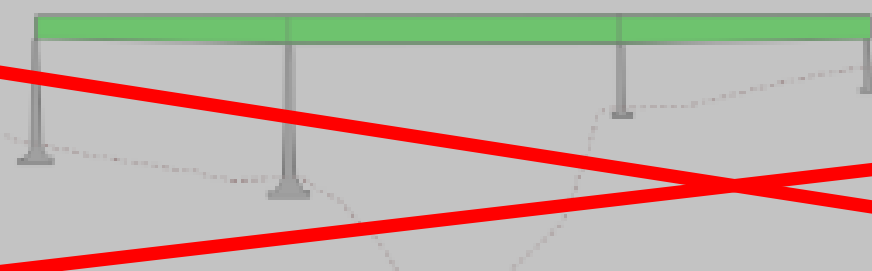
<ul style="list-style-type: none">• Long material lead times• Strength and condition of existing piers and foundations.	6-12 Months	\$\$\$\$
Full Bridge Replacement		<ul style="list-style-type: none">• Environmental, geotechnical, and other considerations	>12Mo	\$\$\$\$\$

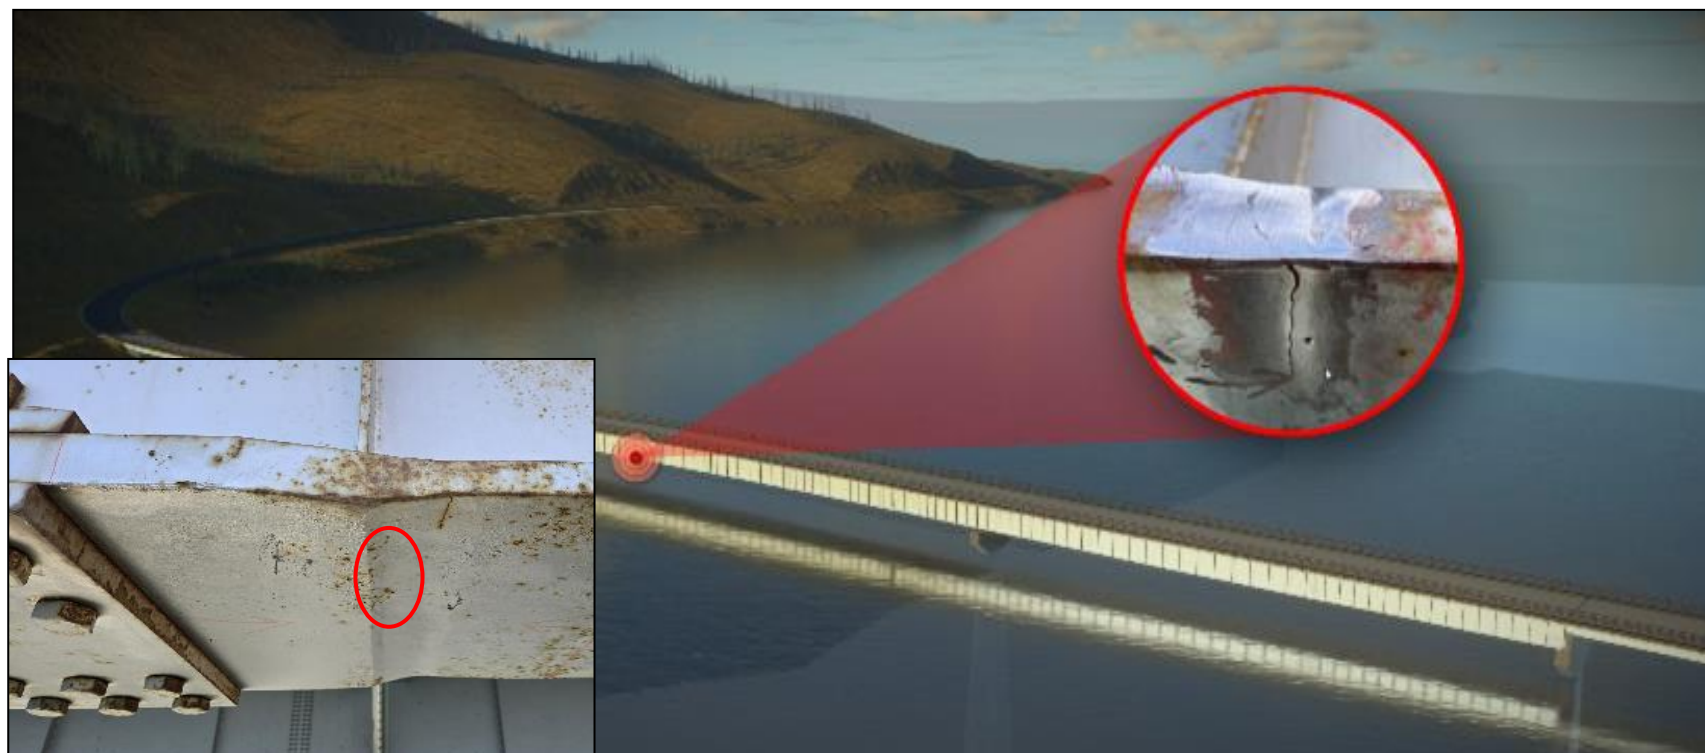
Bridge B Critical Repairs - Designed for speed

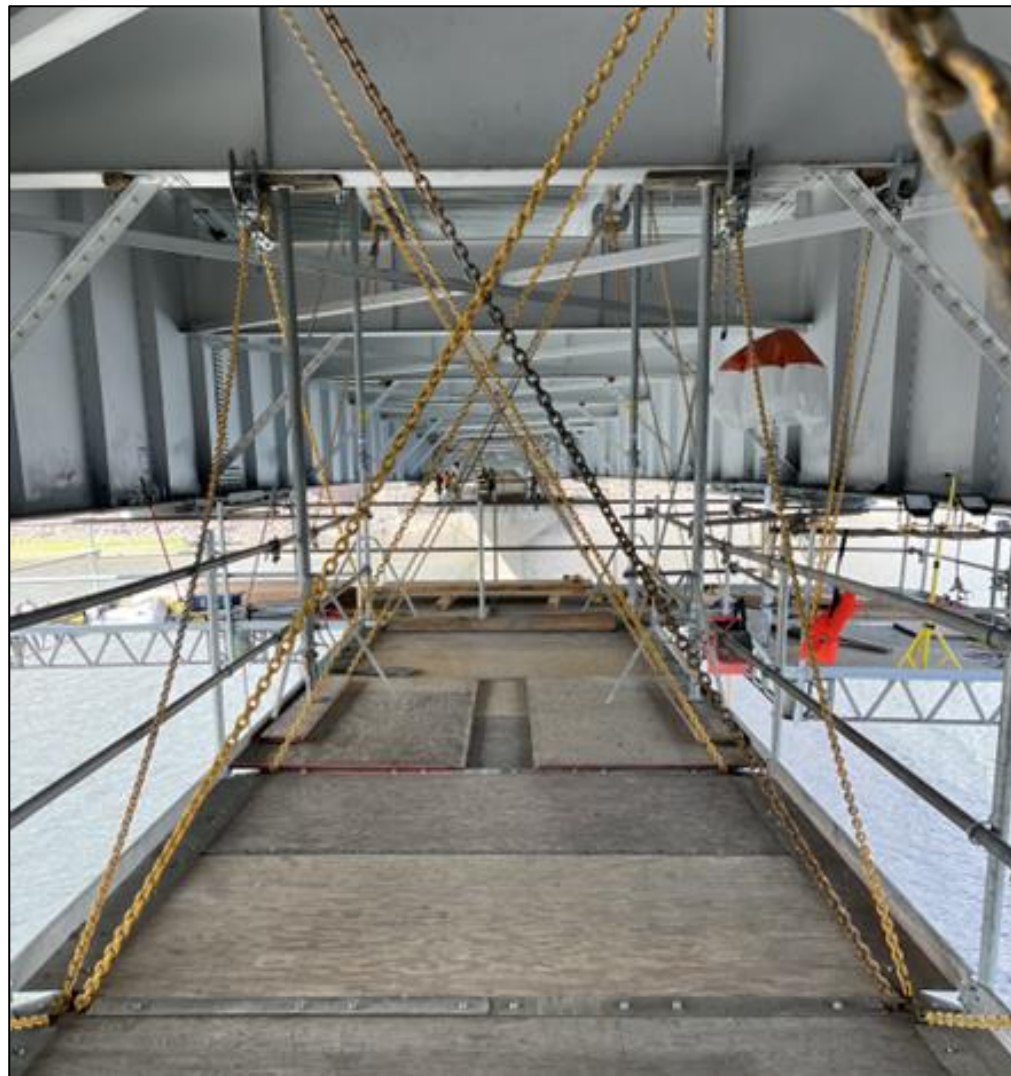
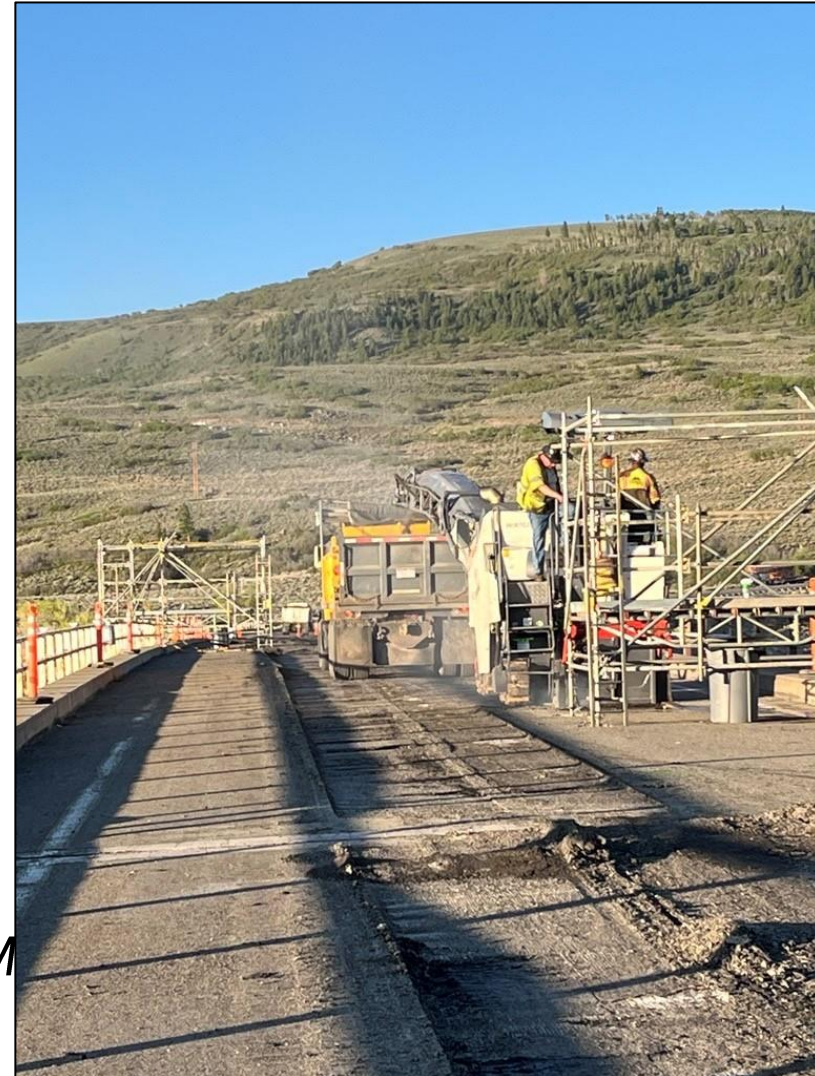
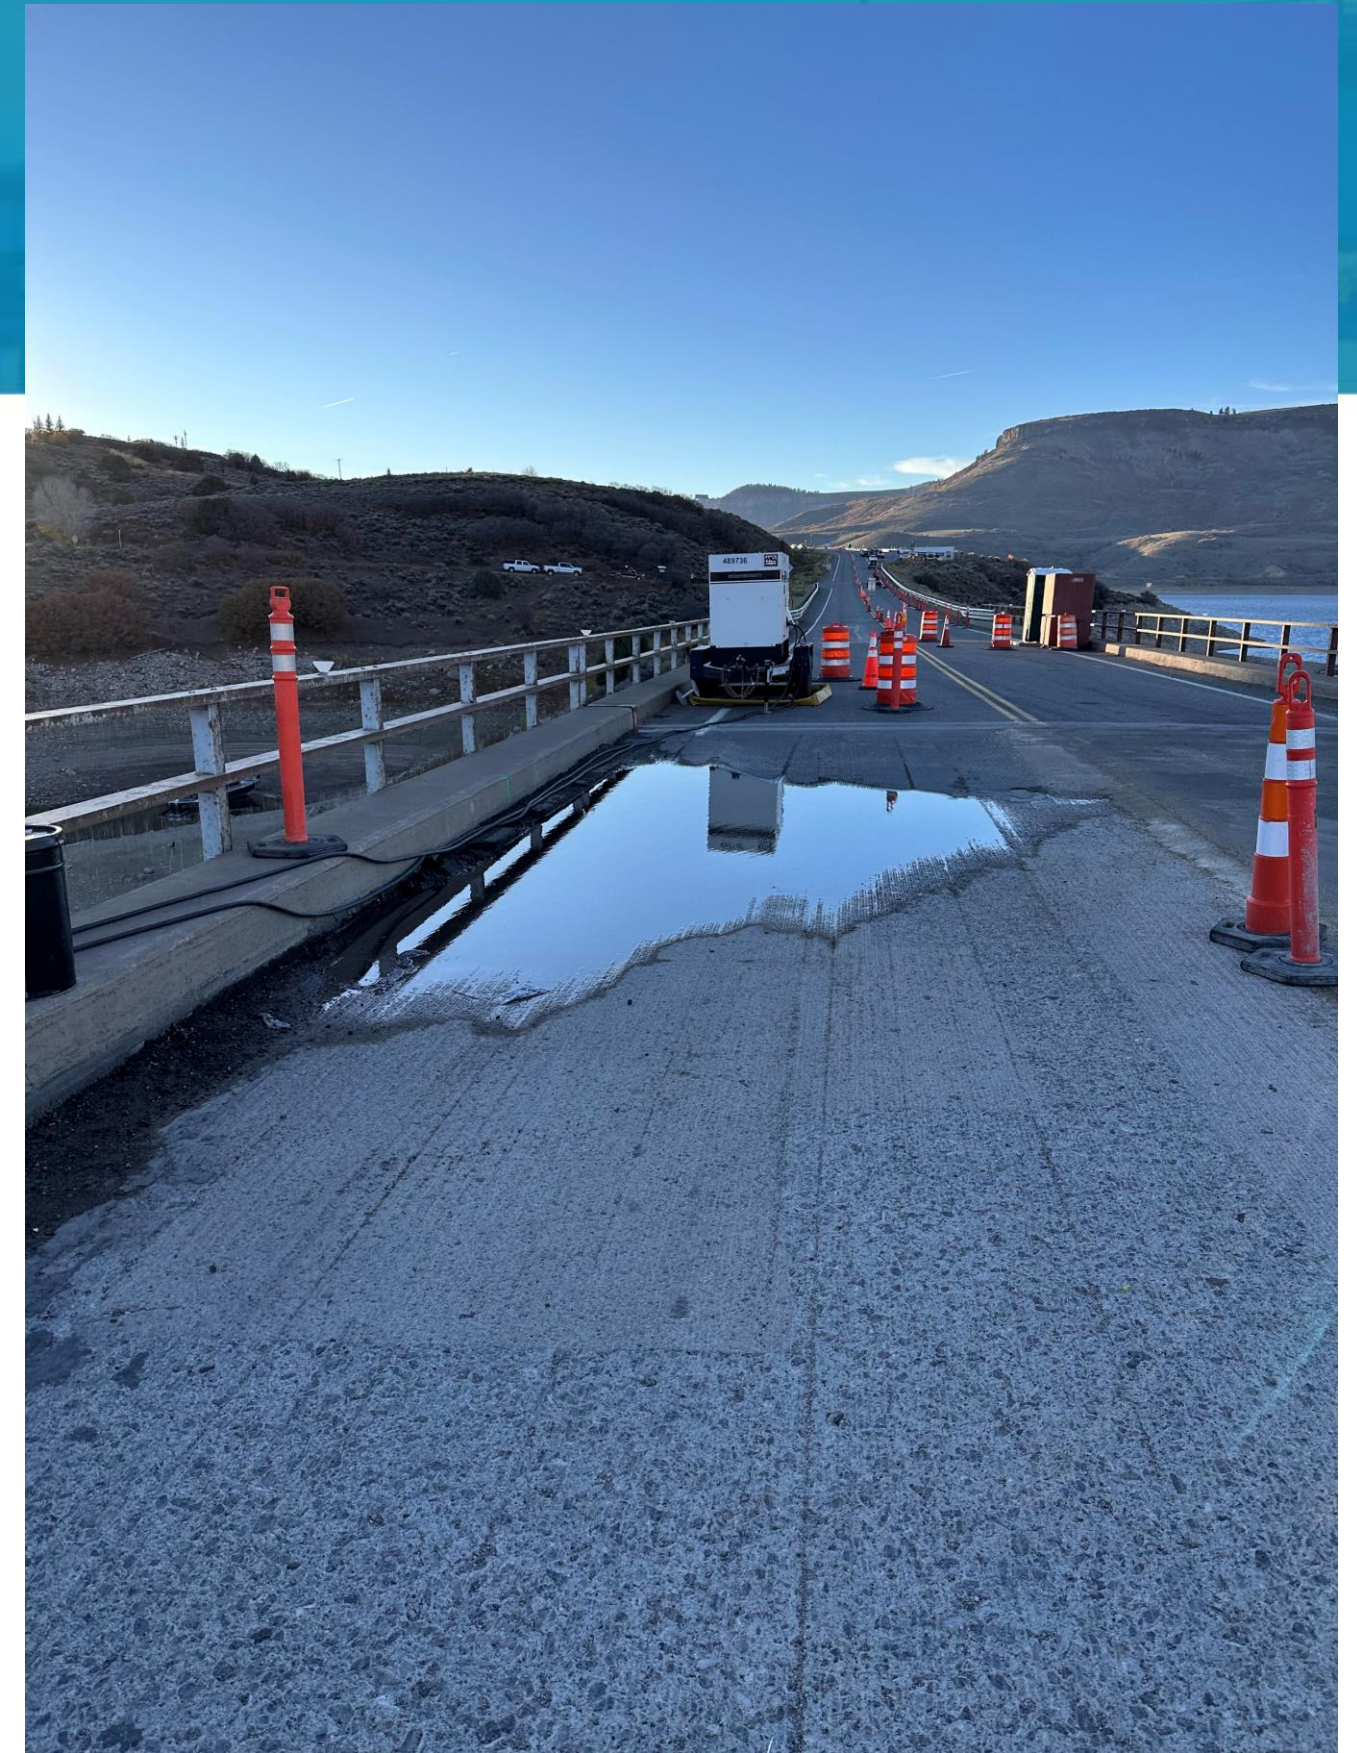
Bridge B – Safe Working Loads

Additional considerations

- Working scaffolds (rolling and then underhung)
- Removing three to four inches of asphalt wearing surface to increase load envelope

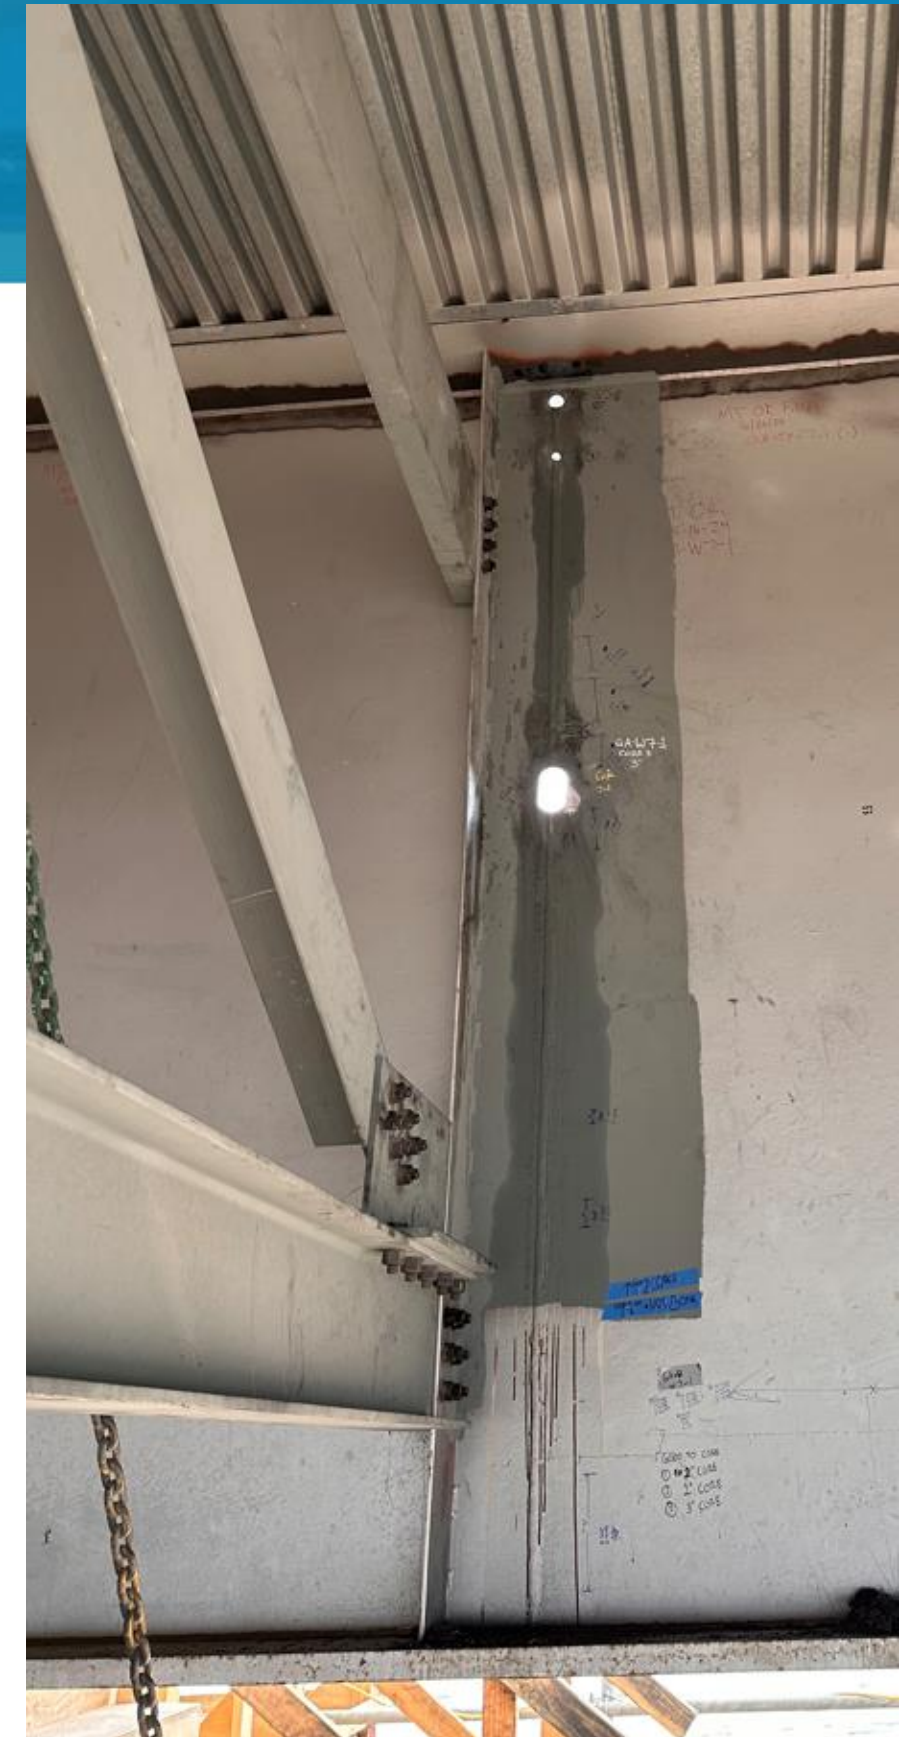
GIRDER SOLUTIONS

1. New definition treating girder as line girder
2. Used model results to rate in spreadsheet
3. Utilized BrR point of interest (POI) overrides
 - Performed LTB hand calculations per 10th Edition of AASHTO and input
 - Determined additional cross frames still required

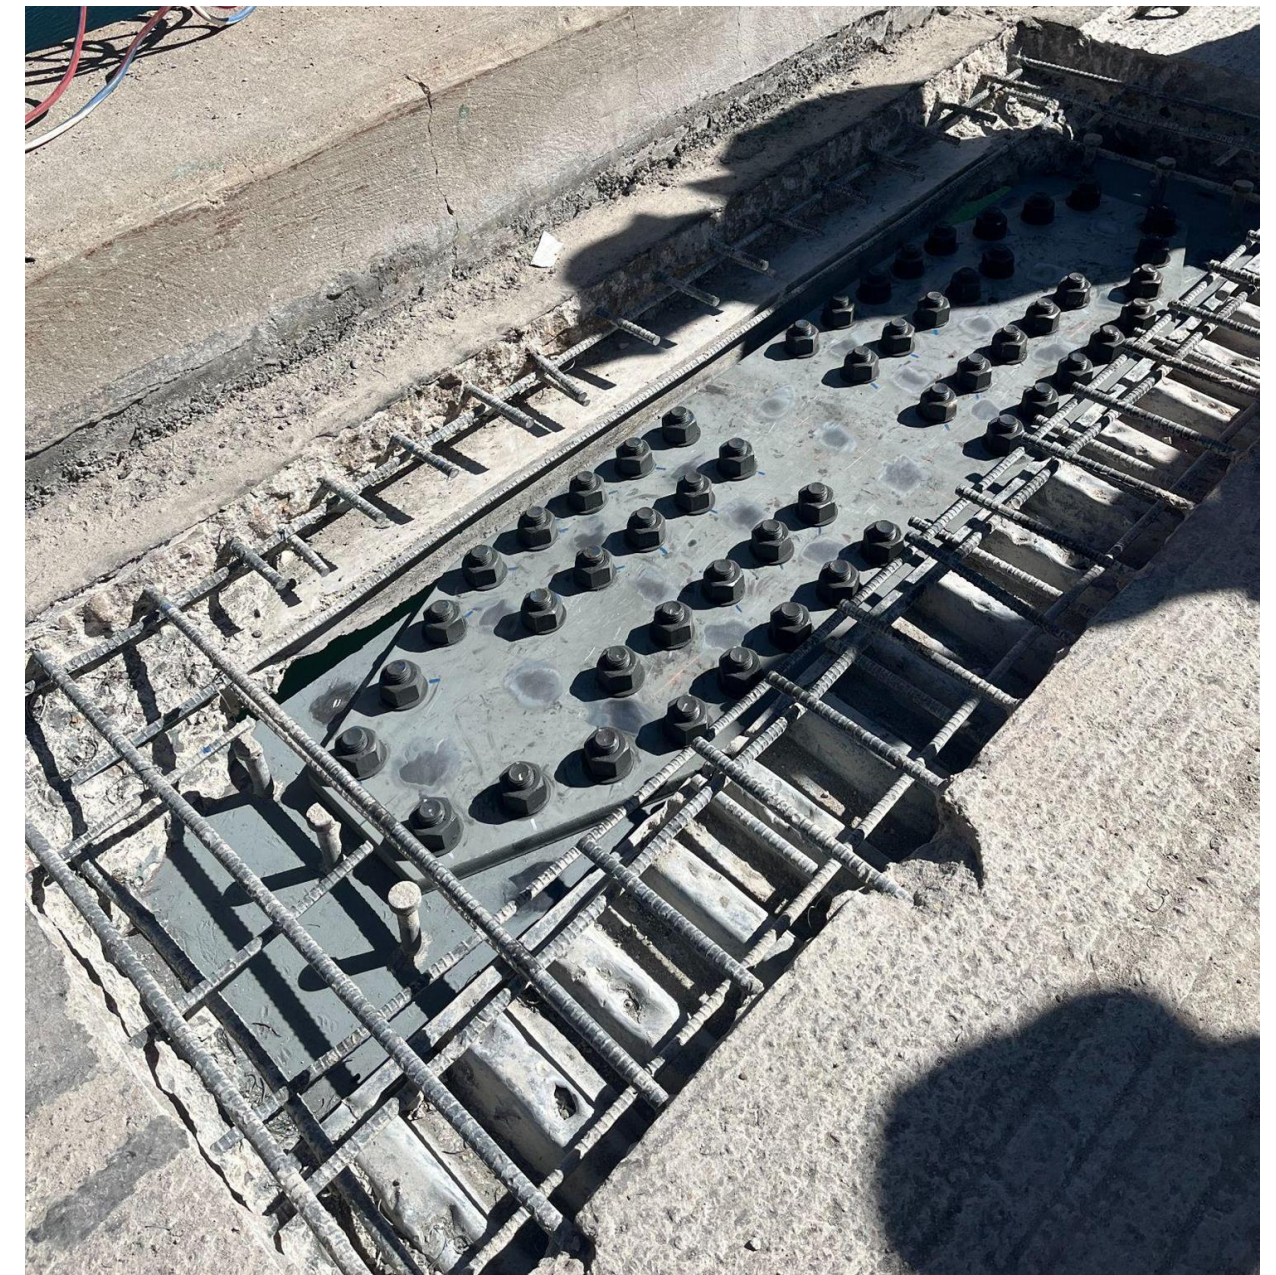
Girder Top Flanges

- Repair plate area assumed adequate since
$$F_y \cdot A_g \text{ of new splice plate} > F_y \cdot A_g \text{ existing top flange}$$
- Reduced existing flange F_y if net section tension controlled over gross section tension of existing flange
$$F_y \text{ applied at POI overrides} = \text{Min} (0.84 \cdot A_{\text{net}} / A_{\text{gross}} \cdot F_u, F_y)$$
- Dead load (DL) of repair plates added as composite dead load (DC2) girder line load

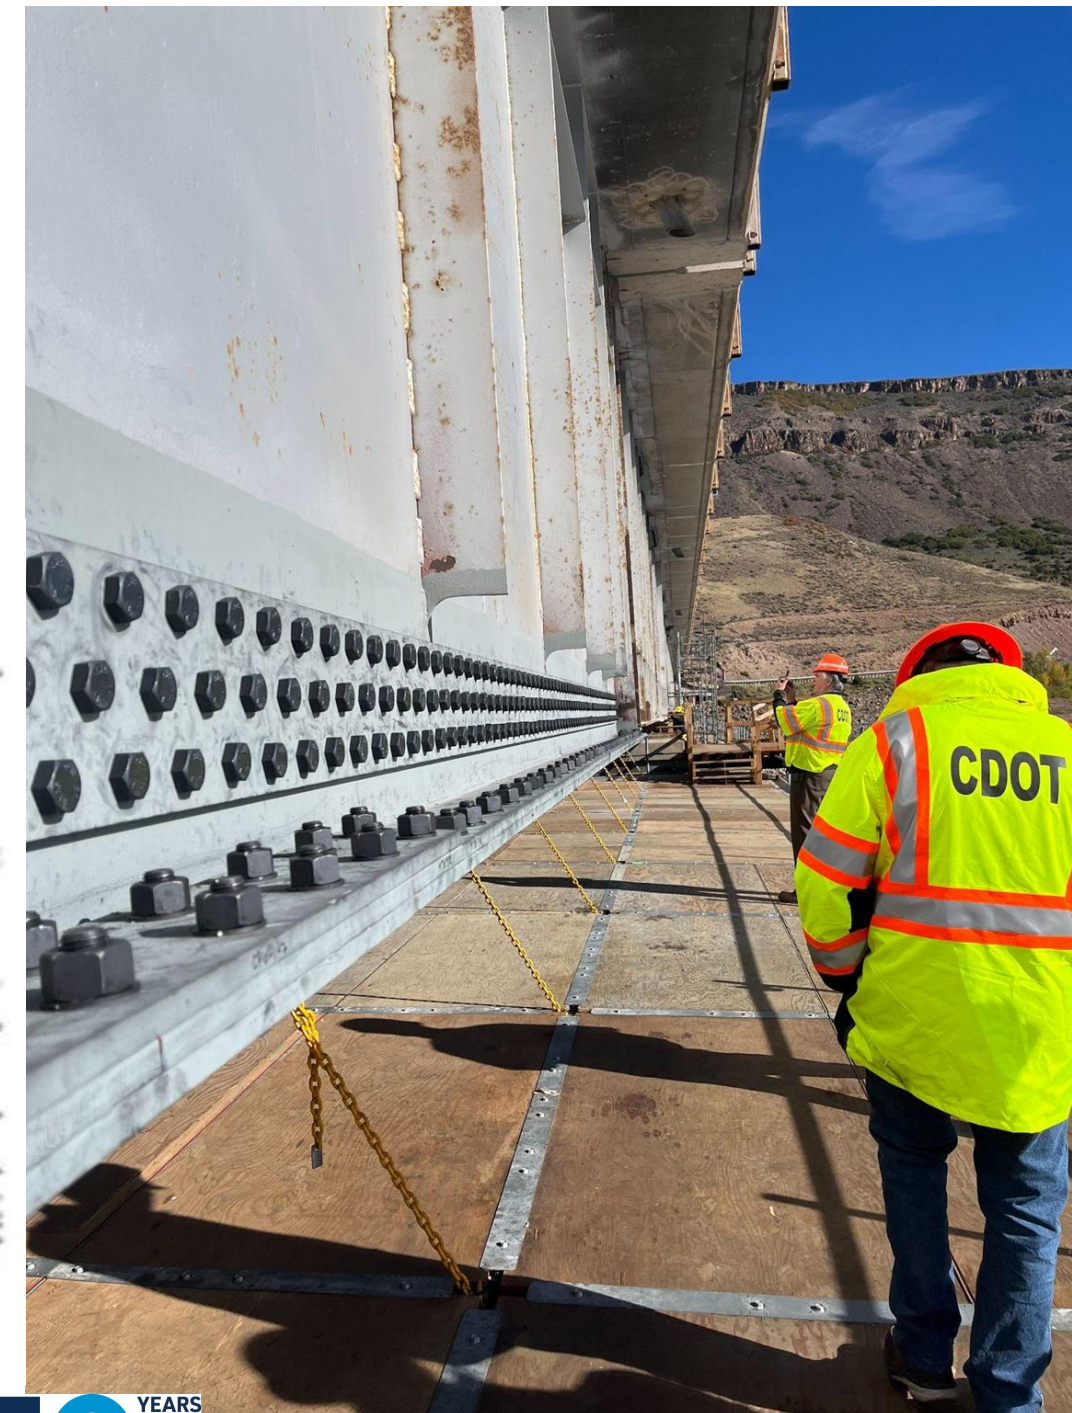
Girder Bottom Flanges

- In repair regions, assume existing flange provides **no** capacity to girders
- Repairs vary from one plate to five plates at a cross-section
 - An equivalent bottom flange -> same area and section
 - F_y of the equivalent flange reduced for net section tension
- Loading
 - Existing flange weight applied as DC1
 - Equivalent repair flange weight removed by applying negative DC1
 - Equivalent repair flange weight added back in as DC2

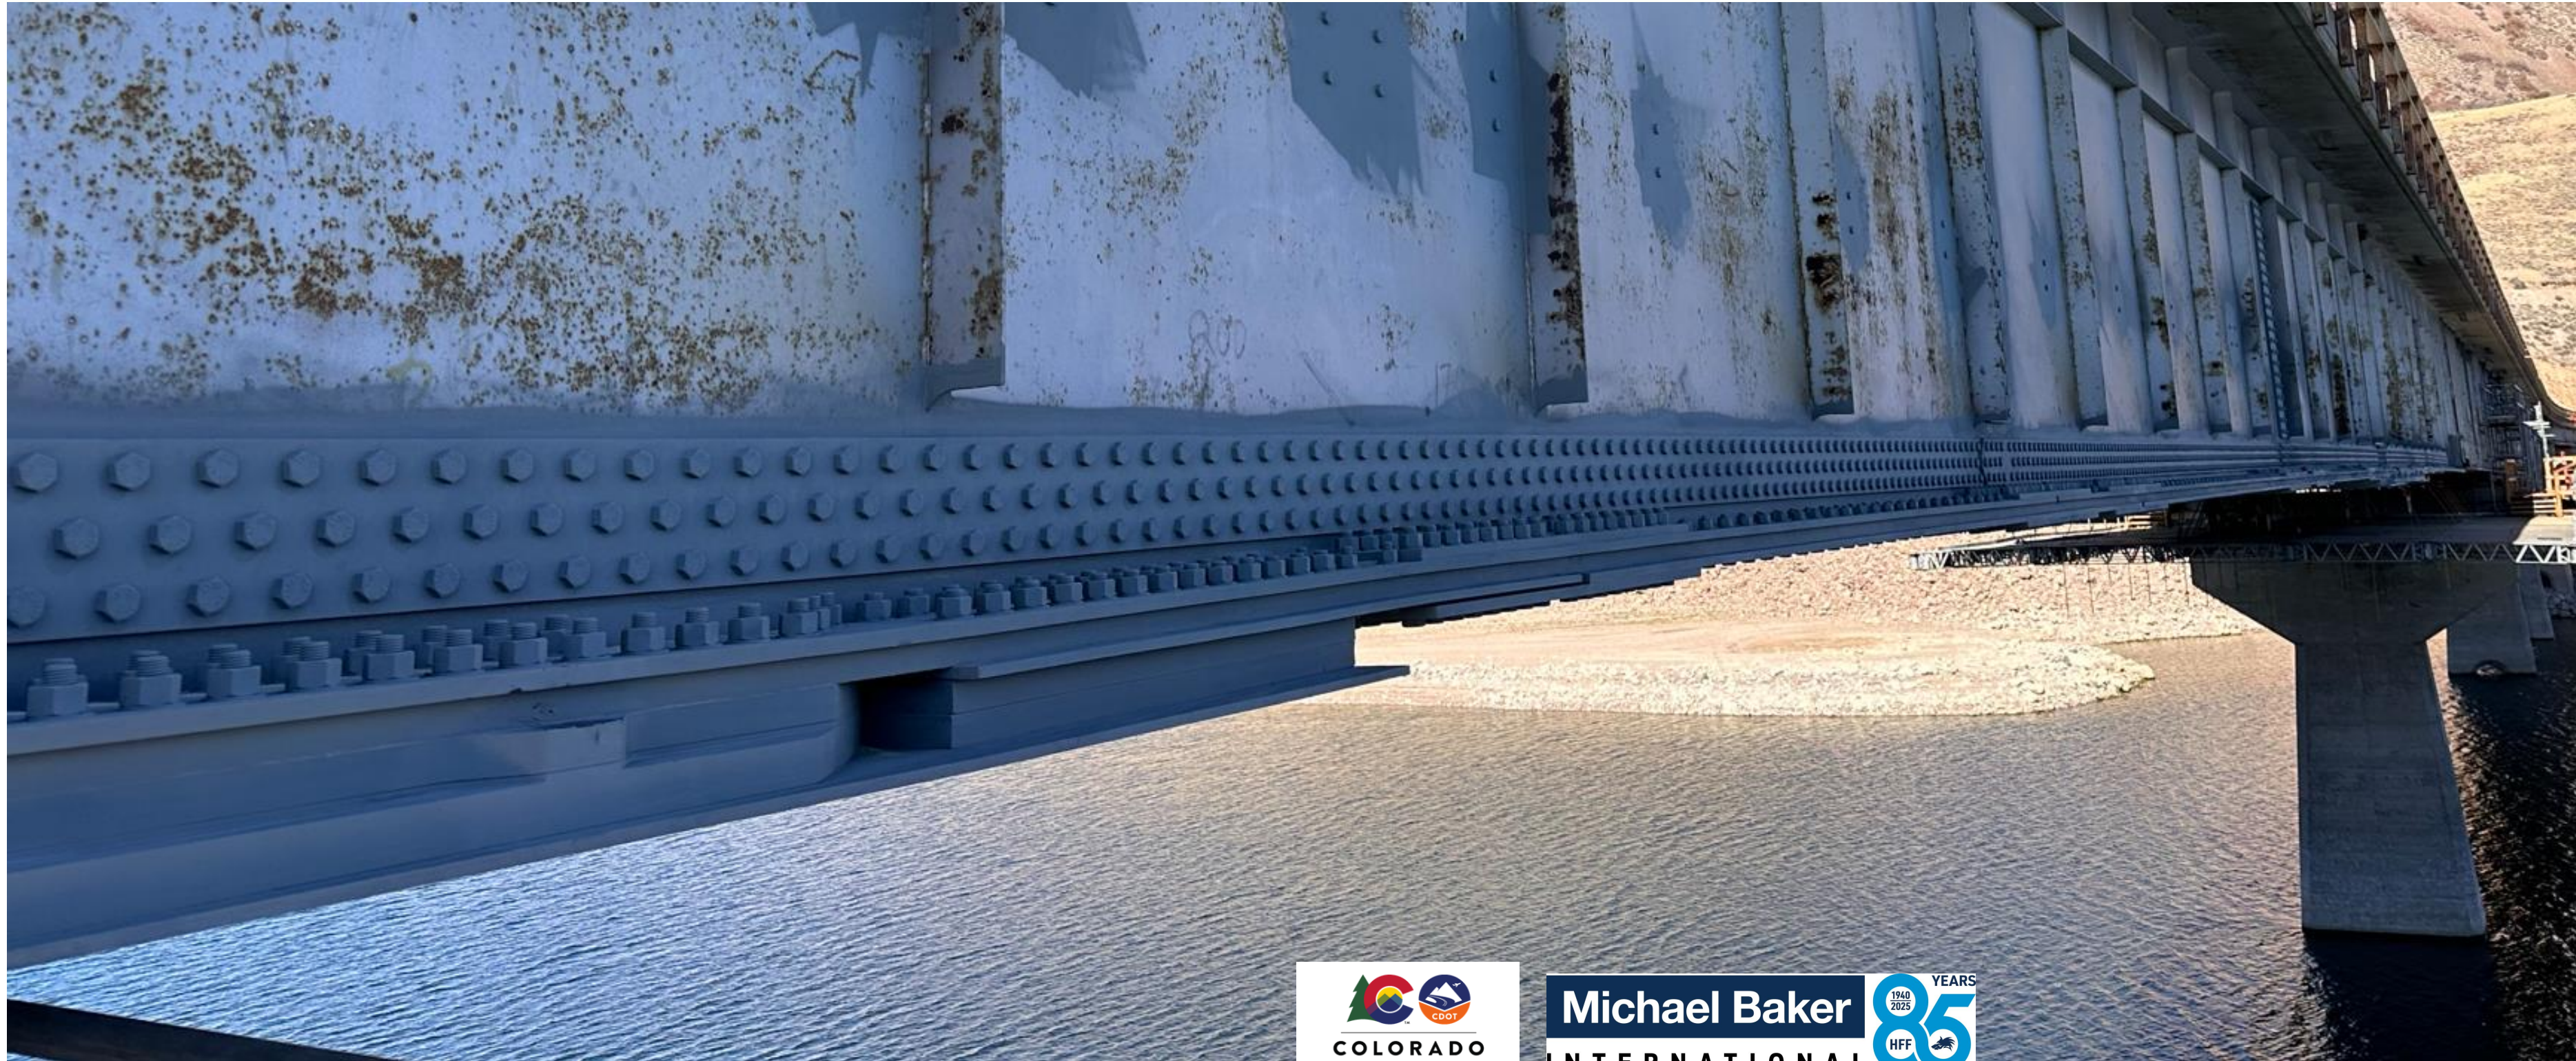
Bridge B – As-Repaired Load Ratings
